Re: Auburn House SHD application

The site forms part of the area which was covered by the Streamstown Local Area Plan, adopted in 2009 and extended in 2014 to last until 2019. At the recent Area Committee where the Fingal County Council planning department were to present the details of the application to the meeting in accordance with s.8 (4) of the Planning and Development (Housing) and Residential Tenancies Act 2016, the planners expressed the view that because the LAP had expired that it was no longer relevant to the planning evaluation of applications within its area.

Proposed Development at
Streamstown and Auburn
Co. Dublin

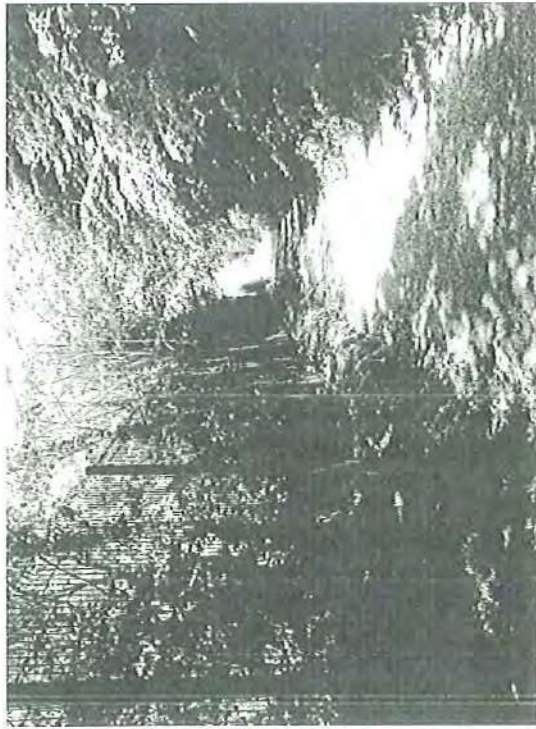
Photo 5

The northern end of this track appears to have been subsumed into the adjoining property and is currently divided from it by the existence of a one a panel fence. In position is to the north of the fence, there is a brick built a wall outside of which there has been developed a close-knit planting of Beech and Hawthorn.
