**Universal Access Feasibility and
Options Report**
Balscadden Bay Beach

Fingal County Council

14th October 2022

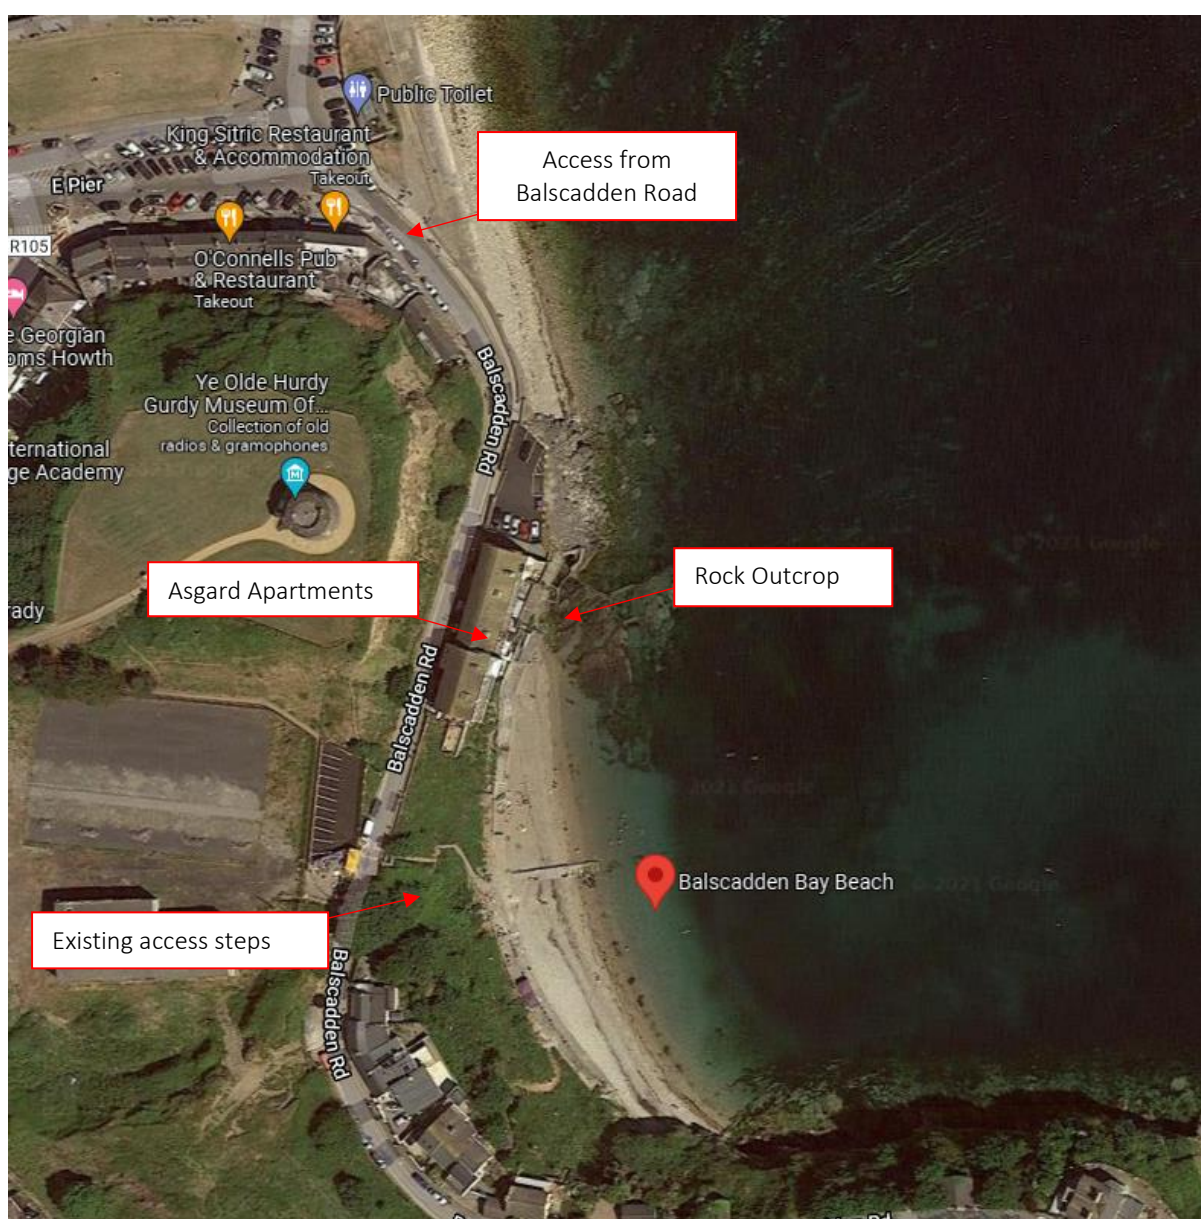
Figure 1 Aerial view of Balscadden Bay Beach showing key features

Balscadden Bay Beach is a sandy beach which runs approximately 100m, from north to south, shown in Figure 1. The upper beach is backed by a concrete promenade and concrete walls, in front of which there is a relatively steep sandy beach. The cliff in this area is roughly 15m high, and the existing concrete access steps from the Balscadden Road at the top of the cliff lie inset into the overgrown cliff face.

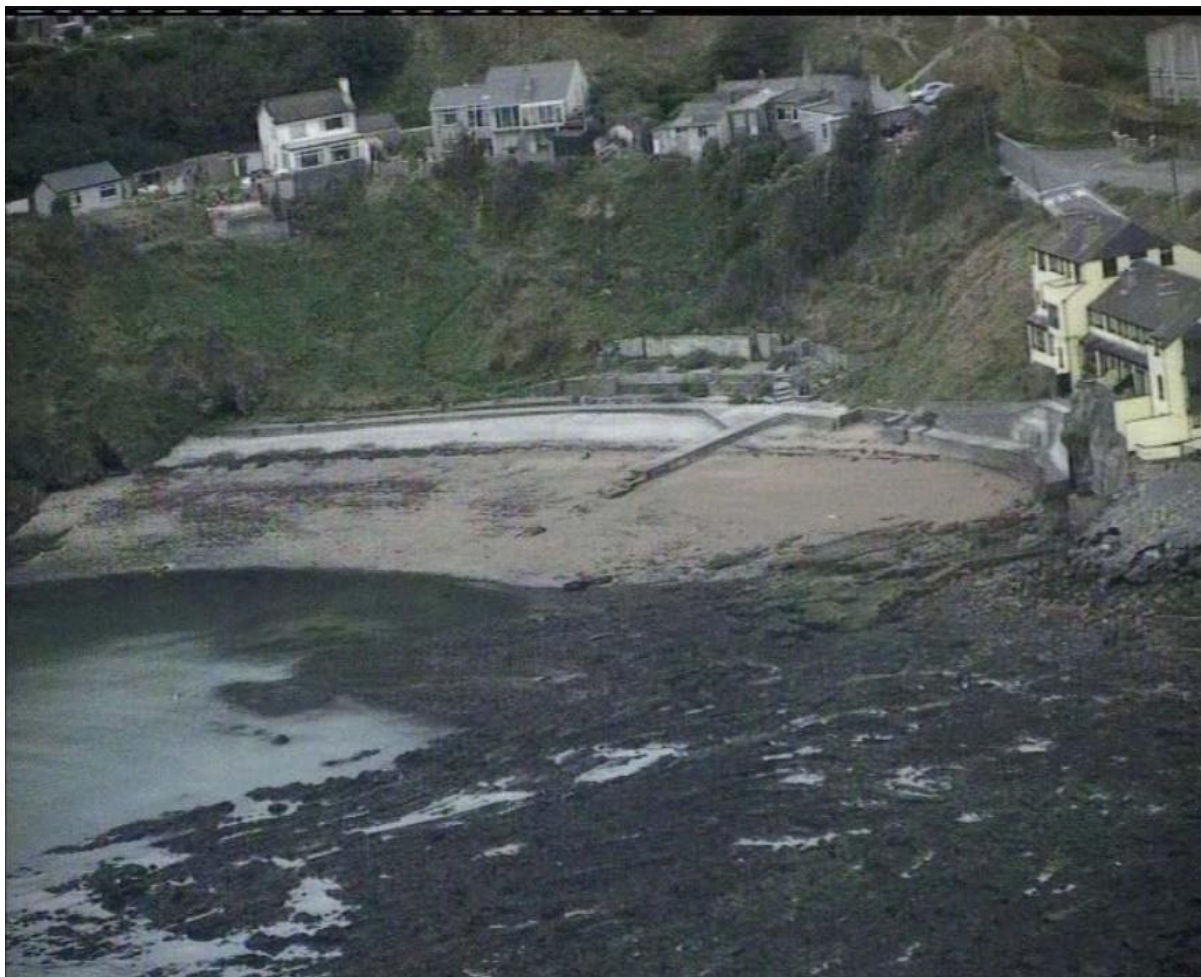
Figure 2 Aerial Oblique Coastal Photograph of Balscadden Beach

An aerial view of the Balscadden Bay beach, from the Coast of Ireland Survey which was flown in September 2003 using aerial oblique digital video photography as part of the Irish Coastal Protection Strategy Study, is shown in Figure 2.

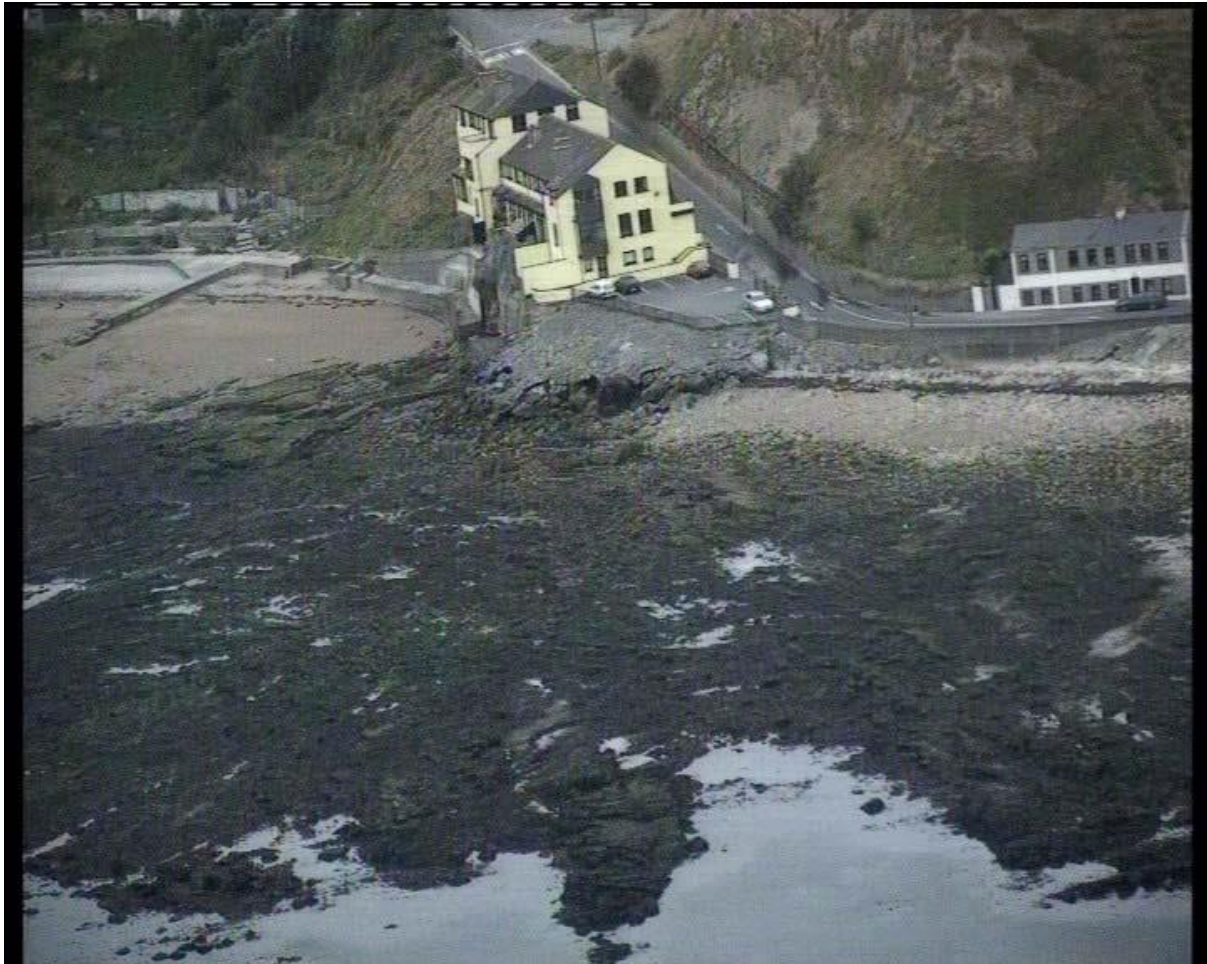
Figure 3 Aerial Oblique Coastal Photograph of Coastline North of Balscadden Bay Beach

To the northern end of the beach is a rocky outcrop, which lies adjacent to an apartment building and a carpark on the coastline. Further north of the carpark, there is a rocky/shingle beach, a sloped stone embankment and a sloped access point to the Balscadden Road. This can be seen in the Oblique aerial photo, Figure 3 below.

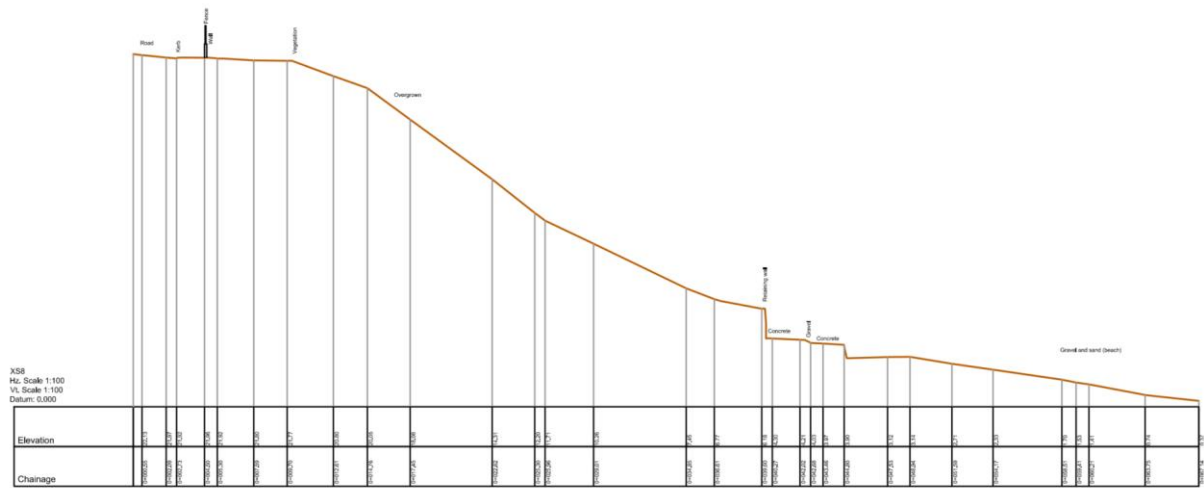
Figure 4 Profile through Balscadden Beach (XS8)

The concrete promenade at the top of Balscadden Beach has an elevation of appoximately 3.9m ODM. A profile of the beach and cliff is shown in Figure 4, showing the ground level at various features of the cliff and beach.

The beach immediately adjacent to the concrete promenade lies at about 3 to 3.3m ODM. Seawards of the promenade the beach drops rather steeply to about 0.5m ODM over 20 metres. The steep slope of the beach can be more clearly seen from the side, from the coast nearby, as shown in Figure 5.

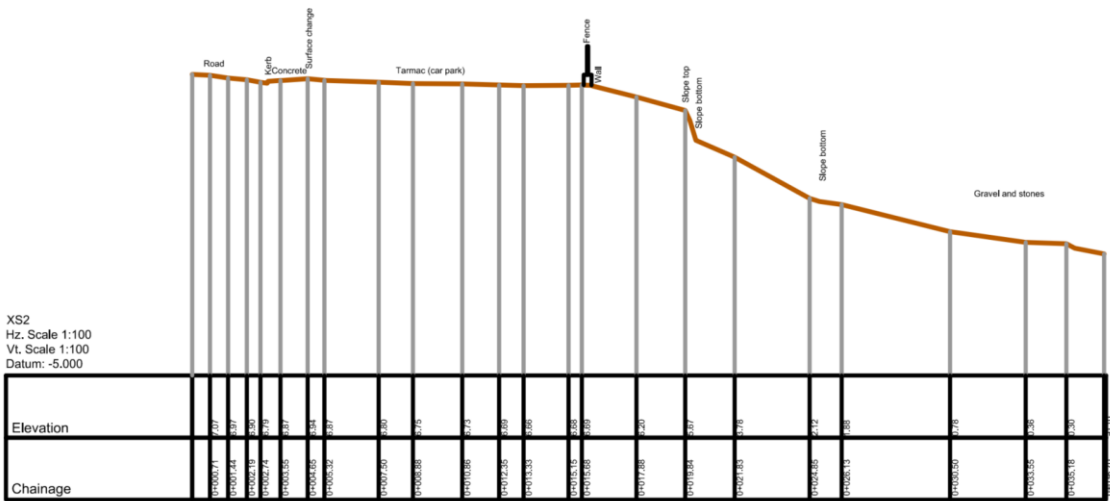
Figure 6 Cross Section at Carpark north of Apartments (XS2)

Further north, around the corner (at Cross section XS2 as seen in Figure 6), there is a carpark adjacent to the apartments and the coast. The car park has a level of 6.75 m ODM. A rock armour slope fronts the car park. It has a crest level of 5.67mODM. The rock armour crest is narrow. The toe level of the armour is 2.12mODM. The overall width of rock armour is 5m and lies at a slope of 1.5:1. The beach level just below is 0mODM.

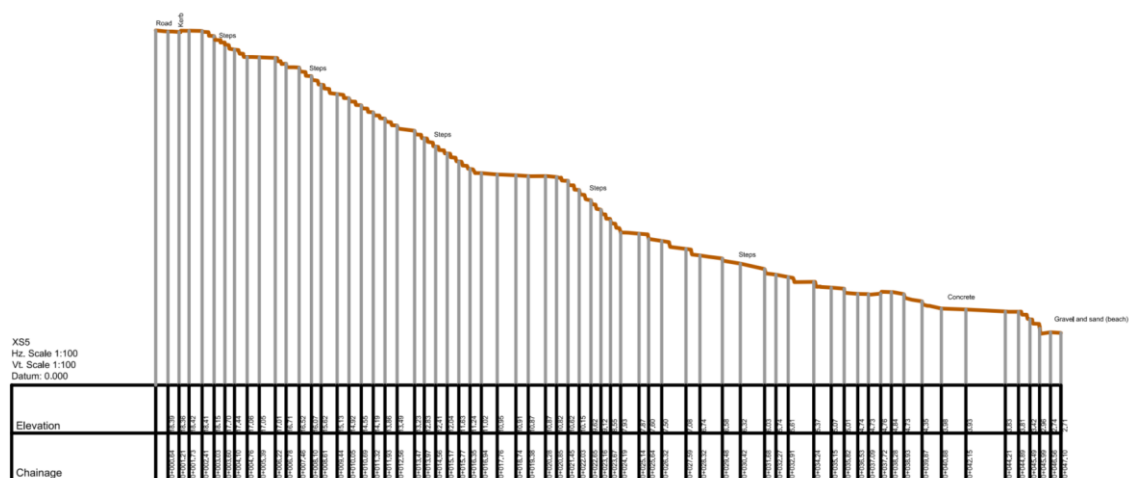
Figure 7 Cross section through Steps (XS5) – along the centreline of the existing access steps

In the vicinity of the existing steps, the top of cliff/road level is 18.39mODM. The top of stairs starts at 18.41mODM and the bottom of stairs has a level of 3.93mODM. This gives an overall height drop over the entire stairway of 14.5m. The total chainage of the existing stairs is approximately 40m. and overall pitch of stairway of 21.1deg along its length. A developed profile through the stairs is shown in **Figure 7** below.

The beach level fronting the stairs is 3mODM.

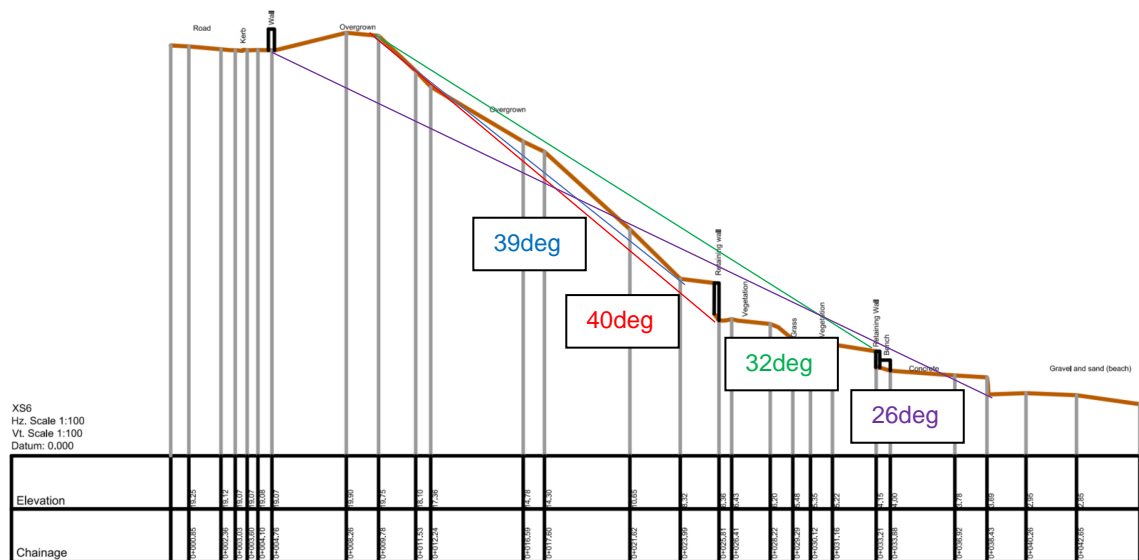
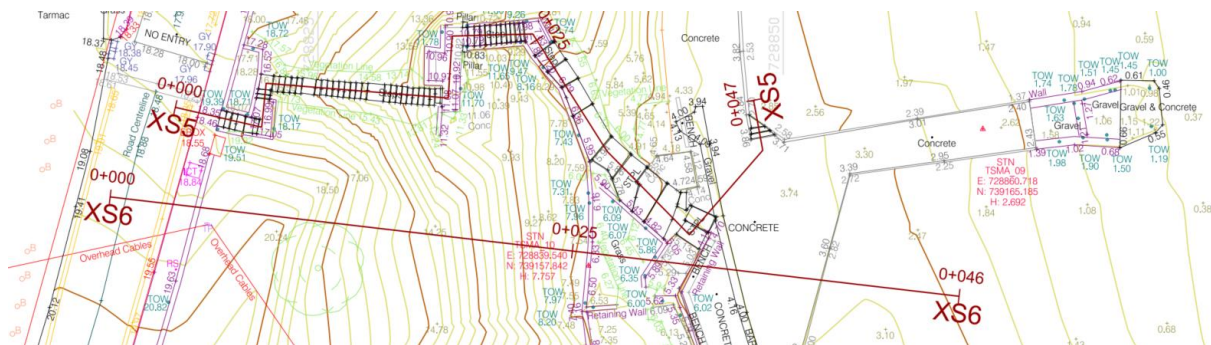
Several lines were superimposed on the profile on **Figure 8** in order to assess how steep the slope of the cliff is in the vicinity of the steps. This is undertaken to allow an assessment to be made of the existing cliff slopes against a probable long term stable slope. The lines indicate:

- At its steepest section, from the top of the slope to the first retaining wall, the cliff has a slope of approx. 40deg.
- From the top of the cliff to the second lower retaining wall, the cliff has an overall slope of 32degrees.
- The overall slope from the top of cliff to the base of the cliff is 26degrees.

The above have implications in terms of the overall stability of the cliff face in the vicinity of the existing steps. See section 3.3 on geotechnical aspects.

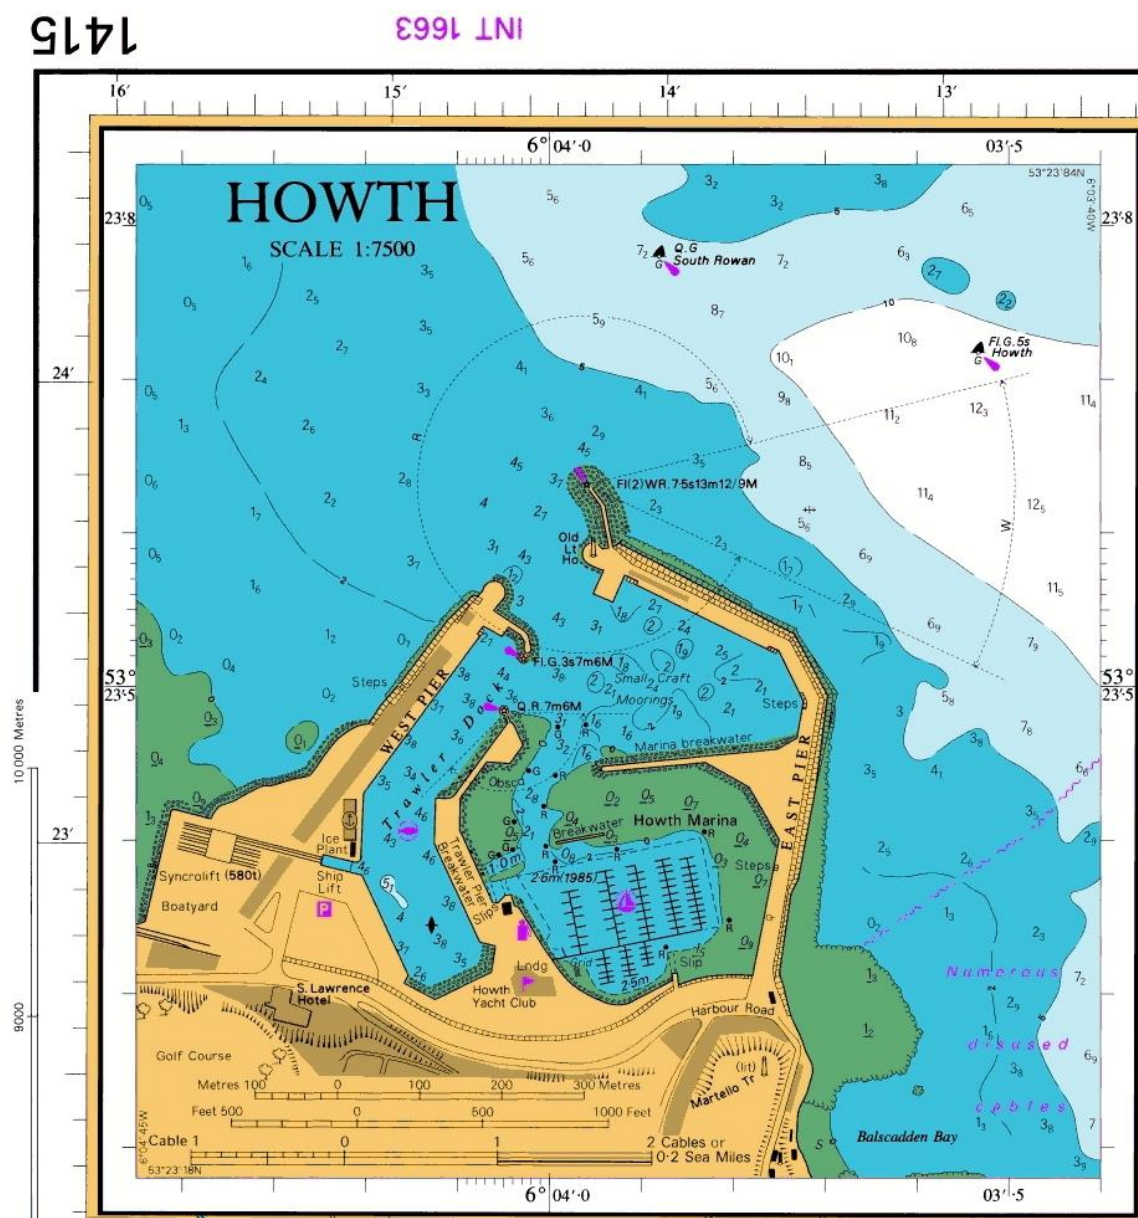
Figure 10 Admiralty Chart for Balscadden Bay, Chart no.1415

Information on the seabed in Balscadden Bay was obtained from the Admiralty Chart for the area, which offers bathymetric detail on seabed levels. In chart no.1415 for Dublin Bay, the coast off Balscadden Bay is shown in the inset detail of Howth Harbour. The depths in the chart below, Figure 10 , are given to Chart Datum, which is 0.2m above OD Poolbeg (ODP), and 2.5m below OD Malin i.e. ODM.

Depths of seabed just off the beach are indicated at 0m Chart Datum, so a level of -2.5 m ODM offshore from Balscadden beach.

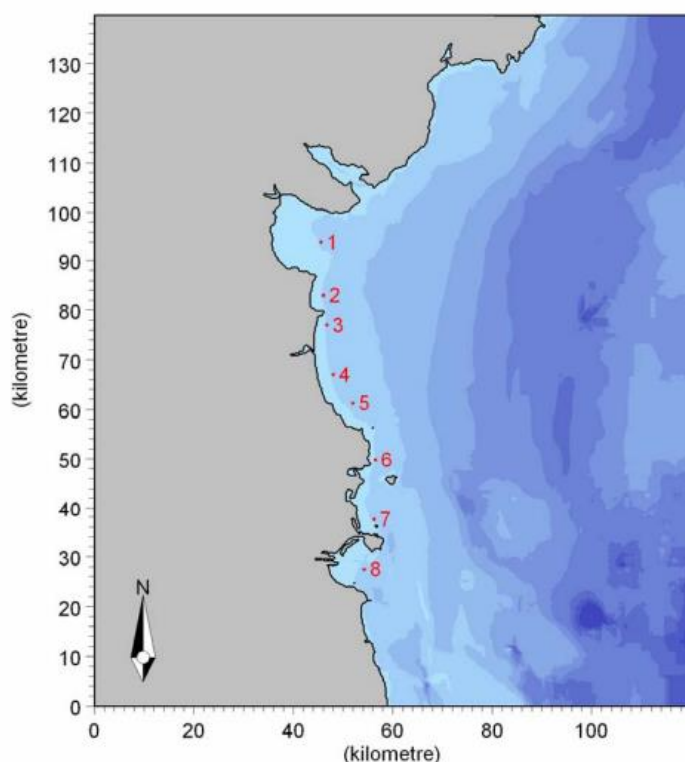
Figure 12 ICPSS North East Coast Inshore Wave Climate Estimation Point Locations

The Irish Coastal Protection Strategy Study (ICPSS) North East Coast Appendix 4, provides Wave Modelling Tables including wave conditions just off Howth. The study uses joint probability analysis to derive extreme water levels around the coastline. The relevant point is Point 7, the nearest estimation point to the study area. It lies north of Balscadden and Howth, and north of Ireland's Eye Island. Such conditions are approximately applicable to the area off Howth Head.

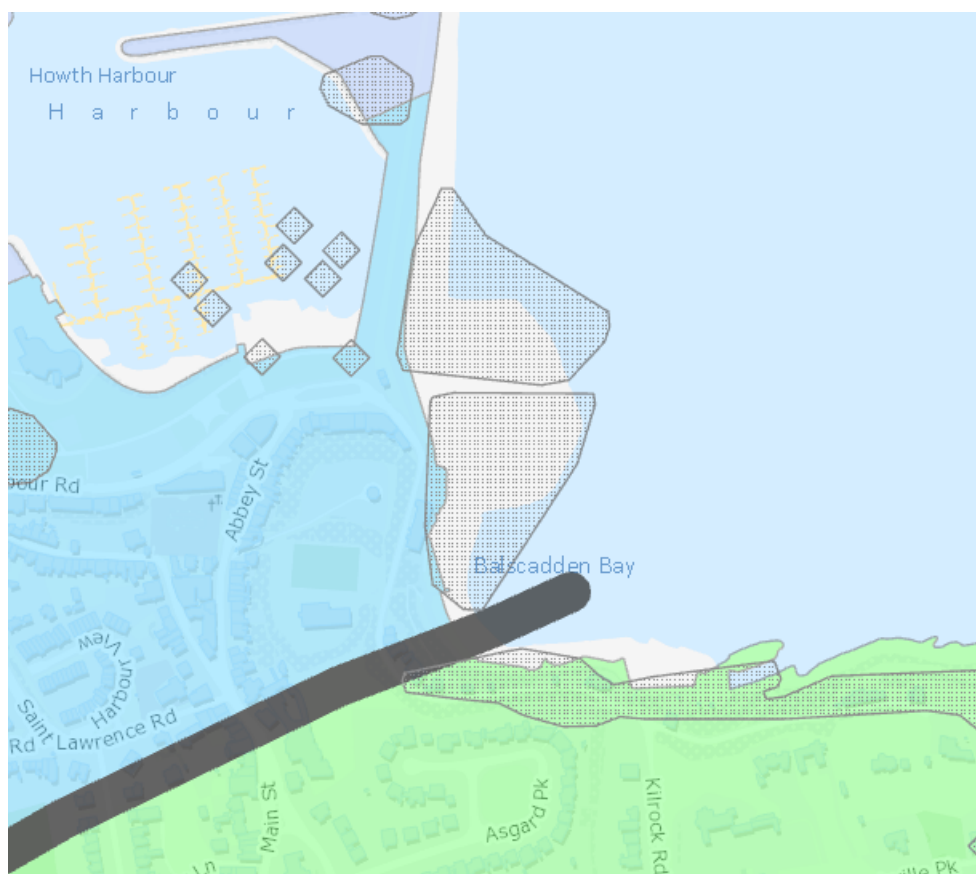
Figure 13 Bedrock geology mapping extract showing Balscadden Bay and its surrounds, from the Geological Survey of Ireland (GSI)

Figure 13 and Figure 14 below are extracts from Geological Survey of Ireland mapping showing the underlying rocks and the overburden material in the vicinity of the study area. The underlying rock consists of:

- the Ballysteen Formation comprised of Dark muddy limestone, shale is shown in blue on the northern half of Balscadden Bay, and
- the Elsinore Formation which is comprised of a polymict melange (an ill-assorted mixture of various fragmented rock types) which is made up of quartzite, greywacke, siltstone, mudstone, and calcareous sandstone in a chaotic mudstone-sandstone matrix. Components vary in size from pebbles to blocks hundreds of metres across.
- The dark area between these two formations is a fault line.

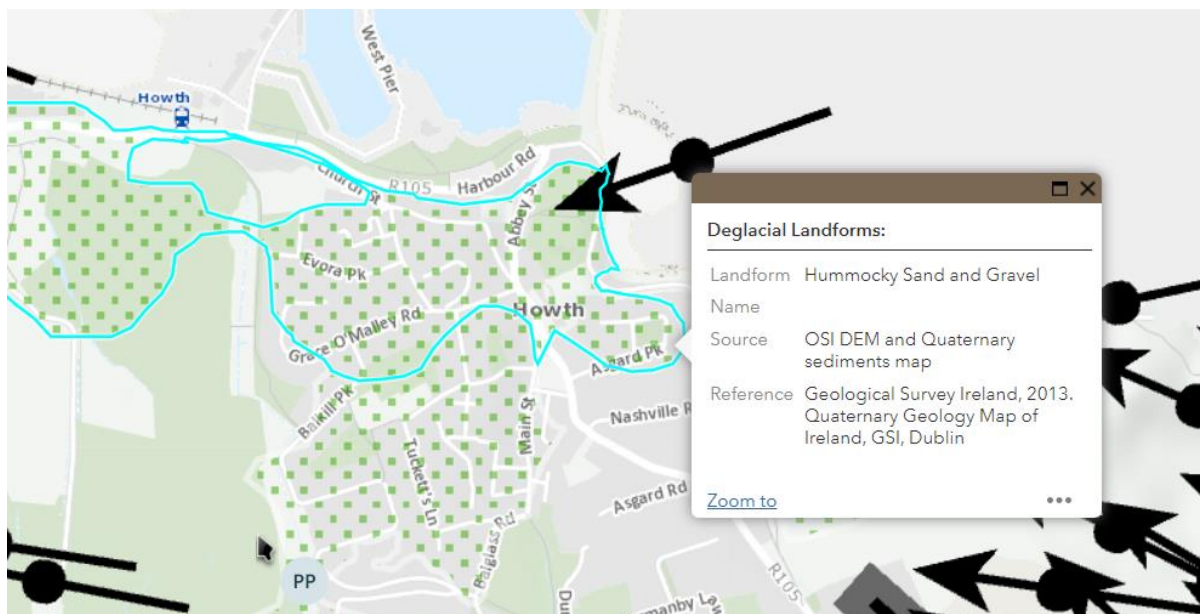
Figure 14 Quaternary geomorphology mapping from GSI, showing Hummocky Sand Gravel Ice marginal landforms along the cliff face at Balscadden Bay

Figure 14 shows the quaternary sediments which form the overburden of soil in the area. It is described as a hummocky sand and gravel over the entire study coastline. It is likely to be a glacial till which is over-consolidated, and can therefore stand at a steeper slope than its long term slope.

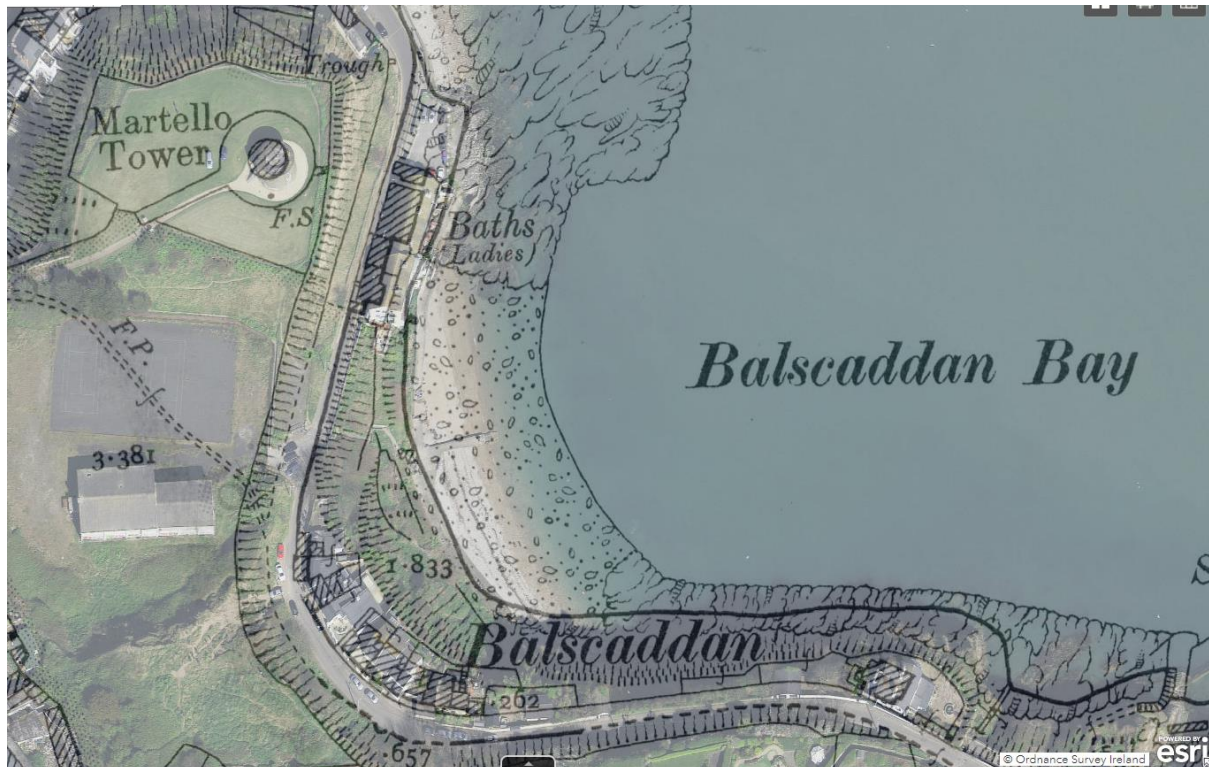
Figure 15 Historic map (1913) compared to recent aerial photography of the area

An overlay of present day mapping with historic 25" mapping, see Figure 15 below indicates that there is little evidence of coastal retreat in the area. Based on evidence of existing coastal defences, in the area, this is not unusual given those defences, and does not mean that erosion poses no threat. And, any beach access needs to be protected from wave action.

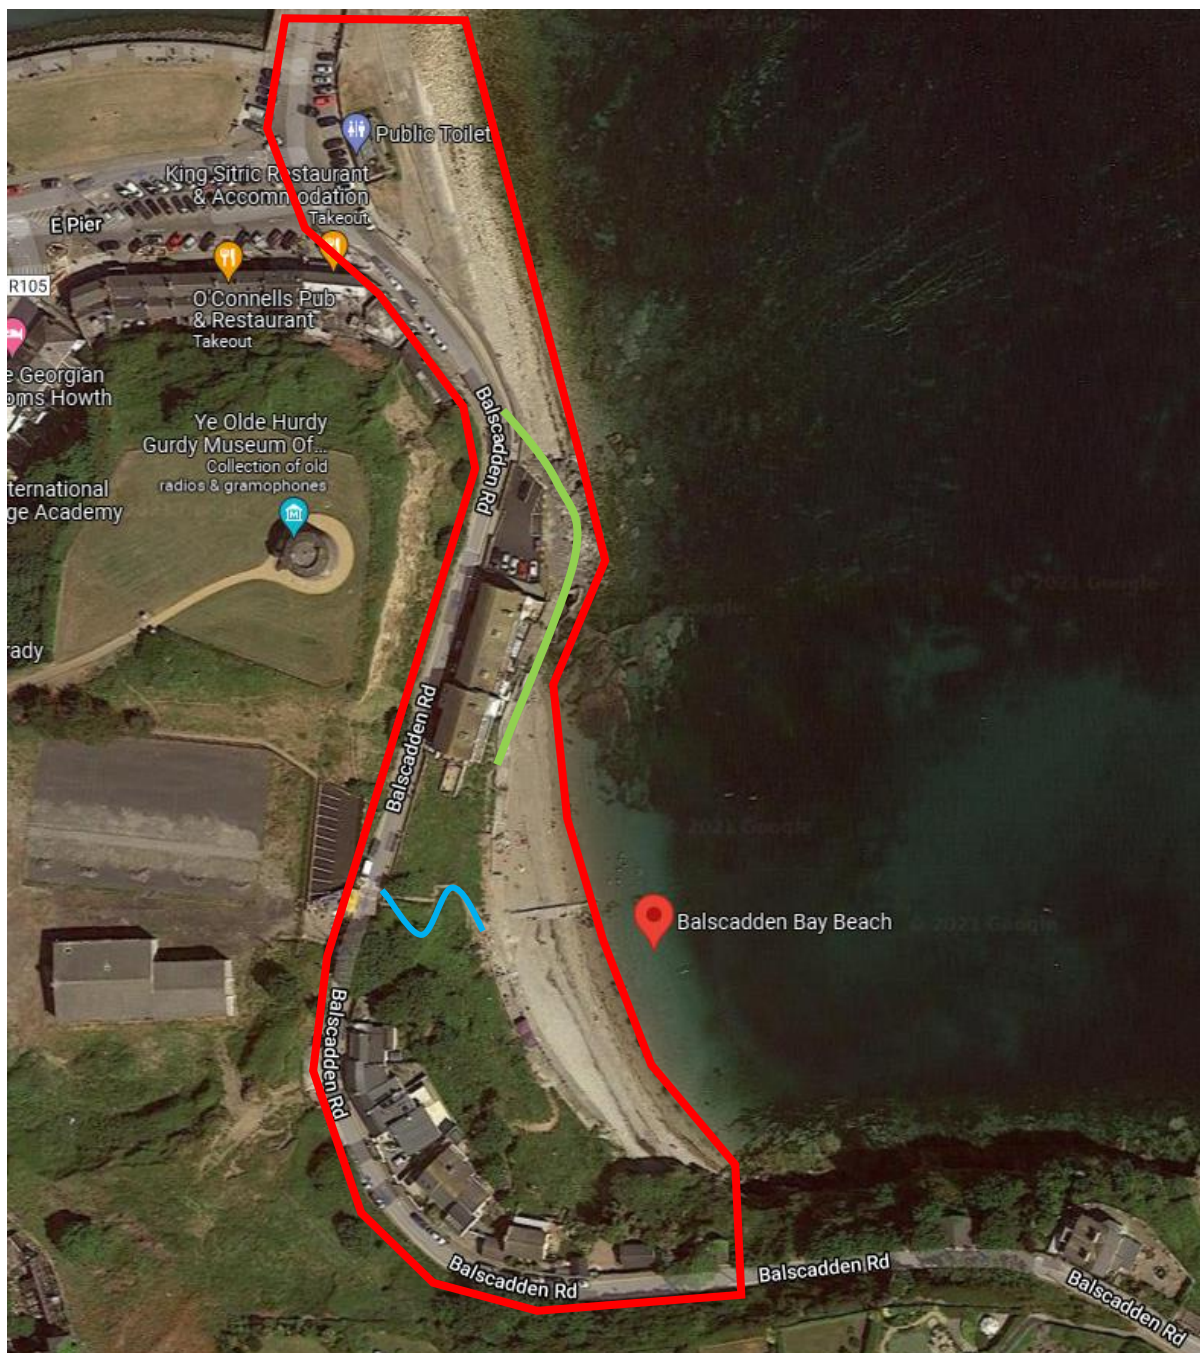
Figure 16 Area of interest, and outlines showing the locations of the potential options costed in this report; Blue: proposed location on cliff of new stair or ramp access, Green: proposed location of new concrete promenade route to the north

- An improved, extended, meandering set of access steps around the site of the existing steps. Cliff stabilisation would form part of such works, which could be beneficial to cliff stabilisation in the area.
- A promenade on the seafront of the apartment complex, connecting the beach to lower ground to the north. Rock armour defense, or specialized concrete defences, of this promenade on the seawards would also add benefits in terms of protection to the coastline in this area.
- Tourist attraction- type access – cable car/funicular/vertical lift/boardwalk.

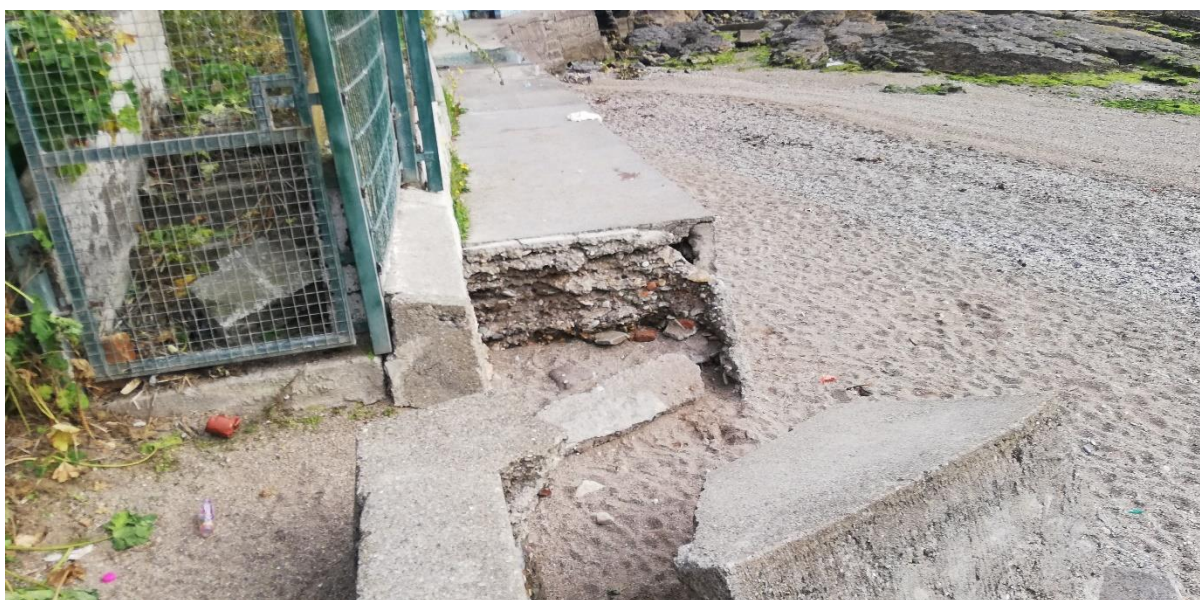
Figure 25 Broken concrete structure along beachfront

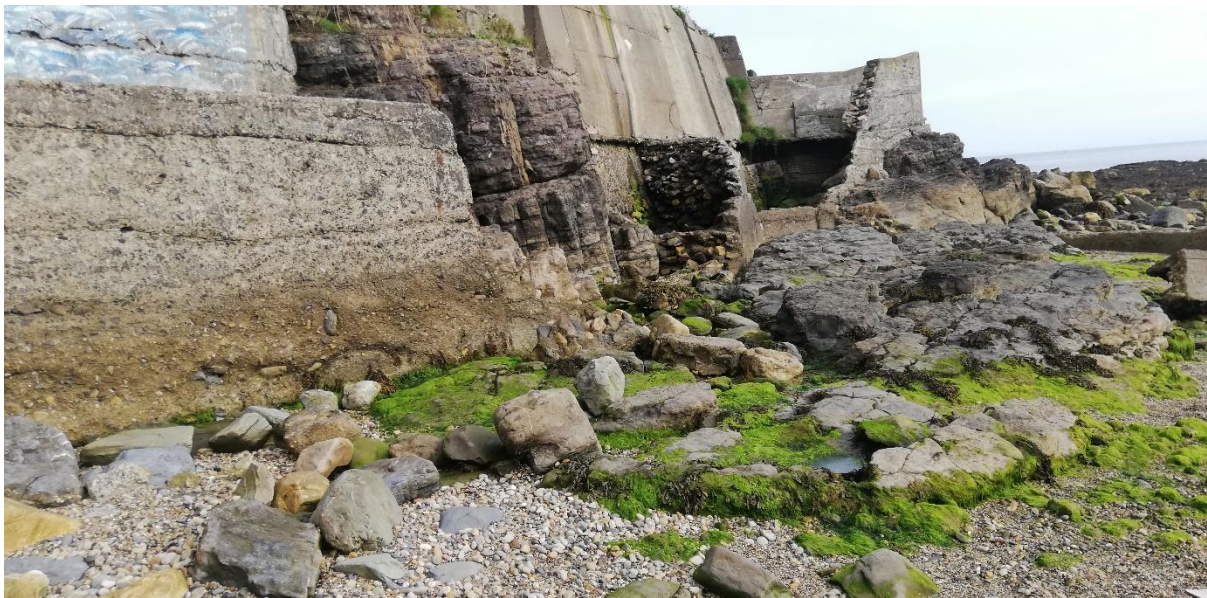
Figure 27 Interface of Concrete wall and rock outcrop, north end of Balscadden Bay Beach

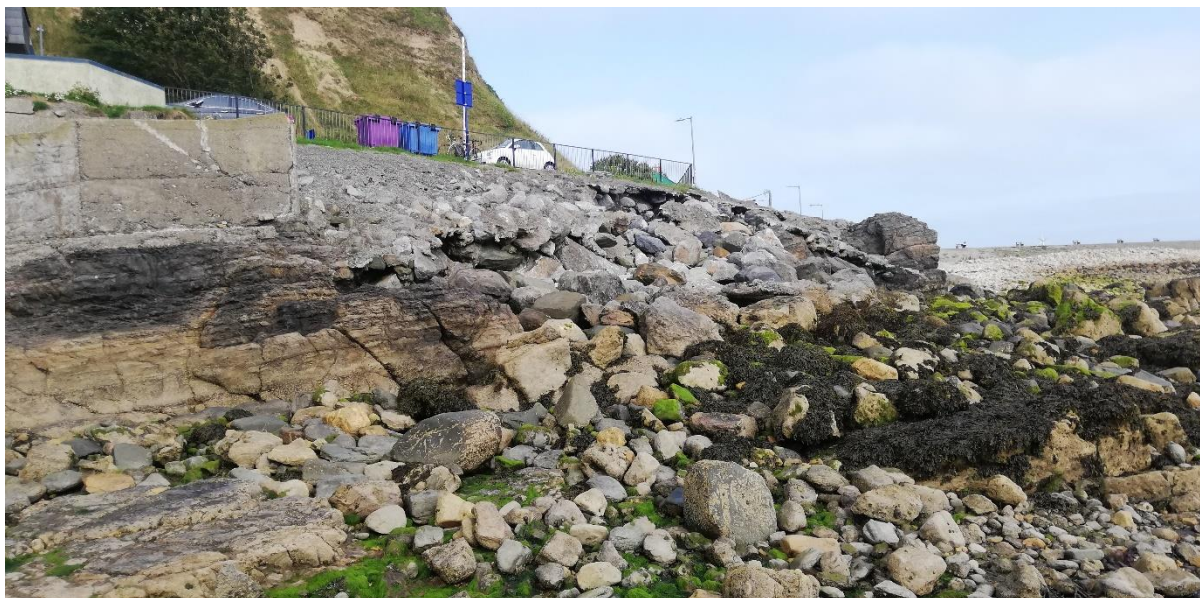
Figure 28 Carpark, as seen from beach, showing rock armour and concrete interface
